# Logan River at Rendezvous Park, Channel and Floodplain Restoration: Crack Willow (*Salix fragilis*) Issues and Management Strategies

Prepared May 2, 2017 by Darren Olsen, BIO-WEST, Inc.

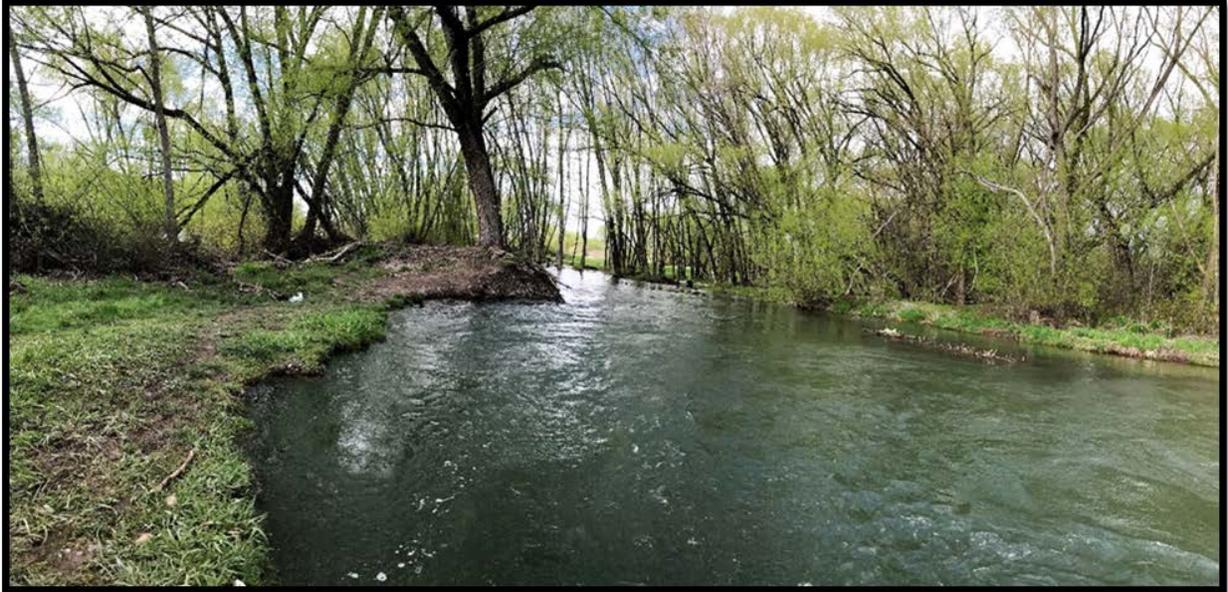
Crack willow thicket along the Logan River at Rendezvous Park. Notice a lack of native grasses, shrubs and trees along the streambanks, and many areas of active bank erosion.

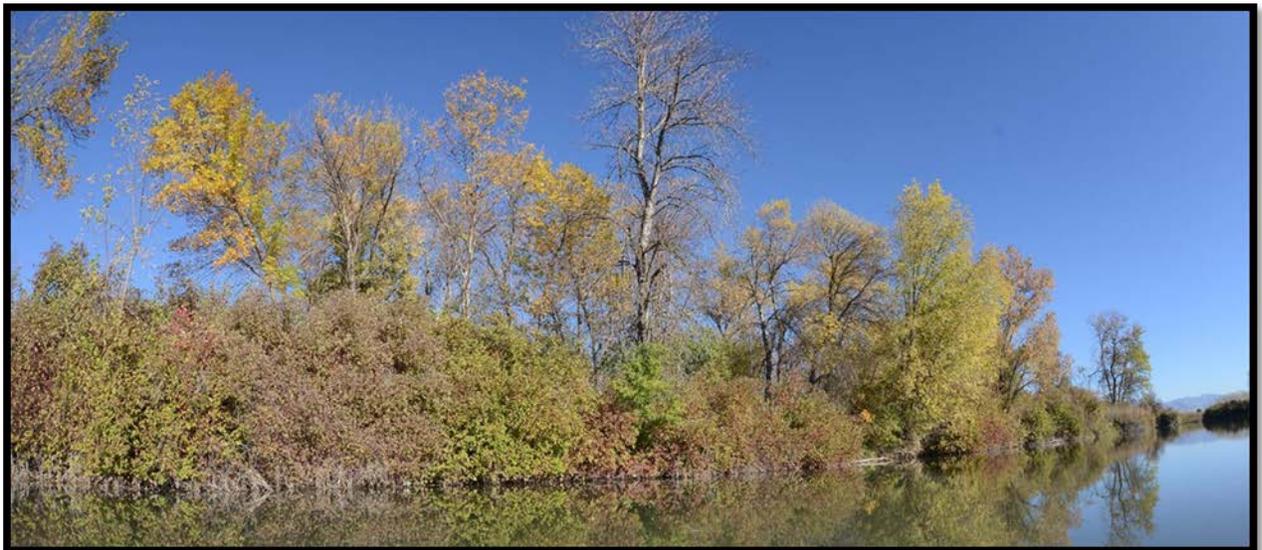
In contrast, this bank along the lower Logan River retains diverse riparian vegetation layers. Near water overhanging shrubs improve instream habitat, protect streambanks, and trap sediments while not causing excessive woody debris accumulation in the channel. Multiple canopy layers provide higher quality wildlife habitat.

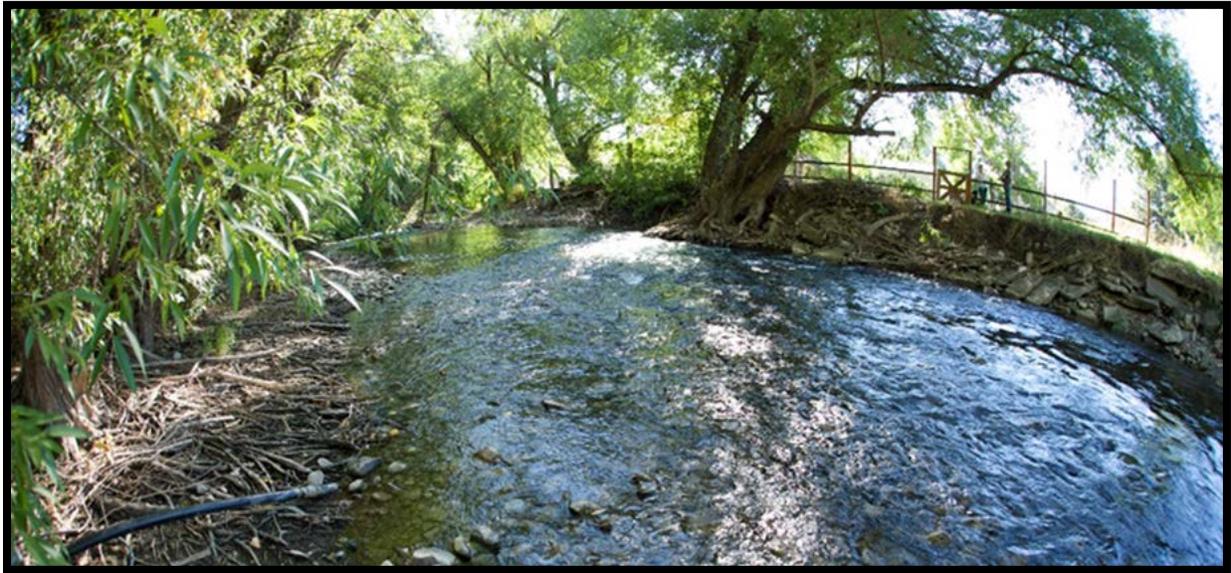
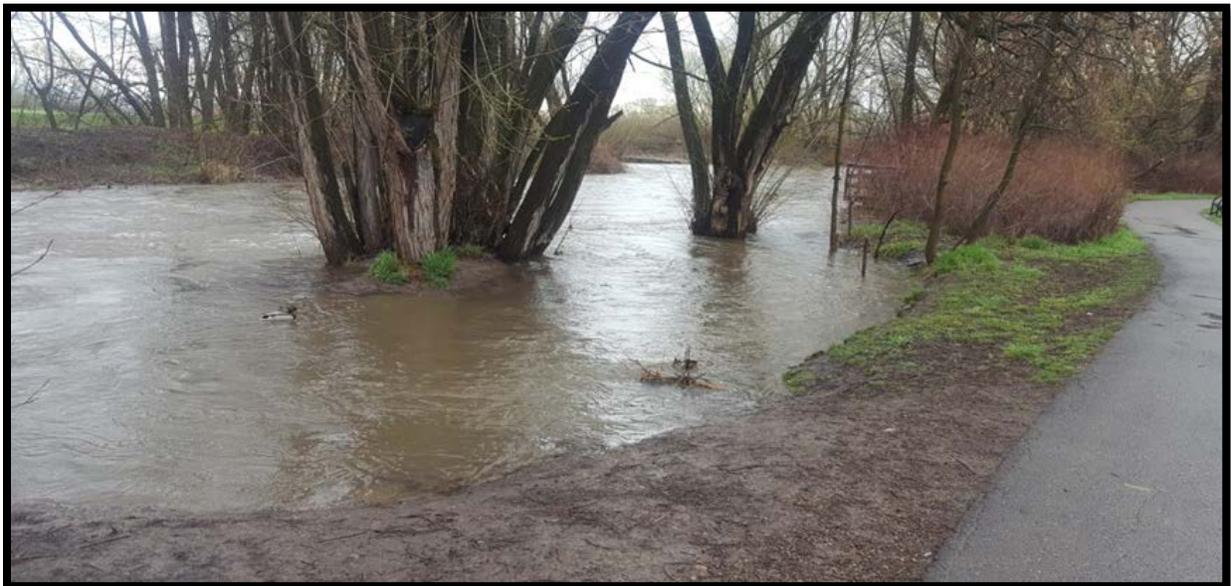
Crack willow trees are often positioned low in the active channel along the Logan River. The massive trunks cause accelerated bank erosion, and serious flood and safety hazards.

Furthermore, mature cottonwood trees are generally positioned above the bankfull channel on older floodplain surfaces, whereas crack willows occupy a lower position on the streambank, sometimes in the active channel. Streambanks under crack willow trees are usually void of a protective ground cover and exhibit high erosion rates. Undesirable concrete revetment is common near crack willows. The dense root structures and large trunks often cause flow blockages, and increase the potential for full channel avulsions to occur. An example of a full channel avulsion happened during the recent 25-year flood event in 2011 when the river suddenly changed its course across the golf course toward Park Avenue. Play at the golf course was impacted for several months from standing water and sediment deposits.

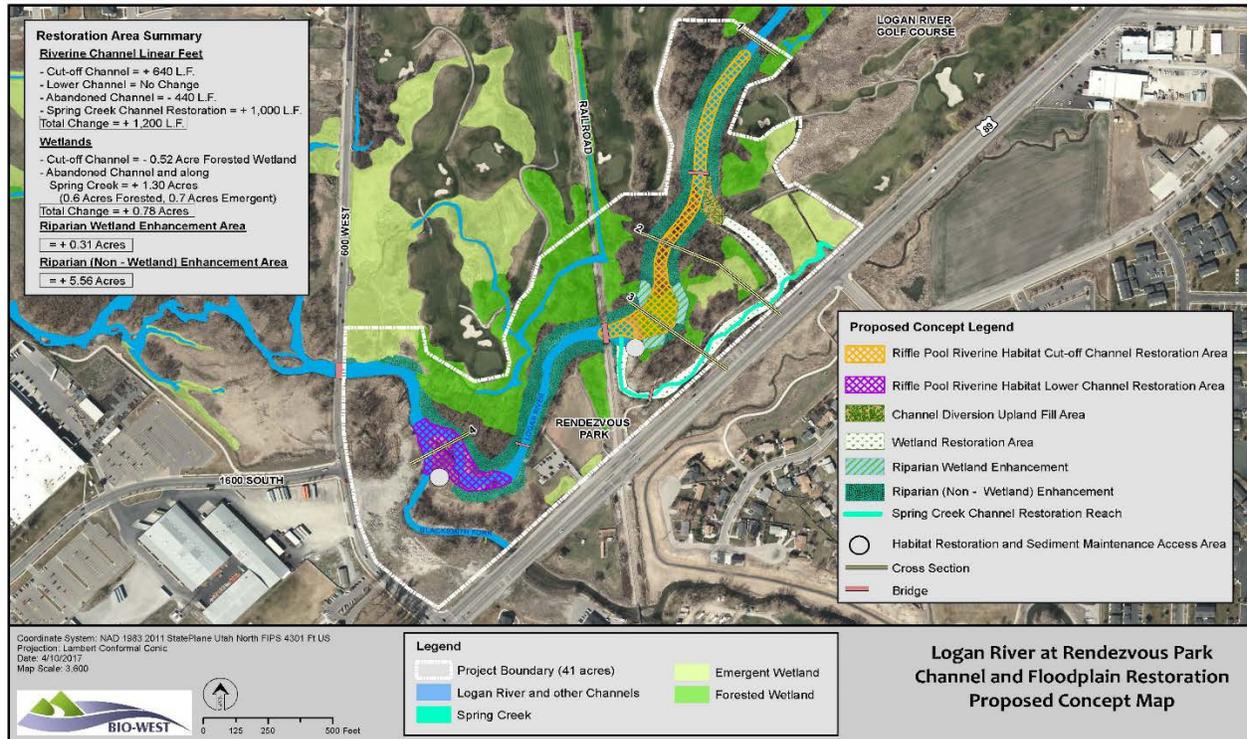
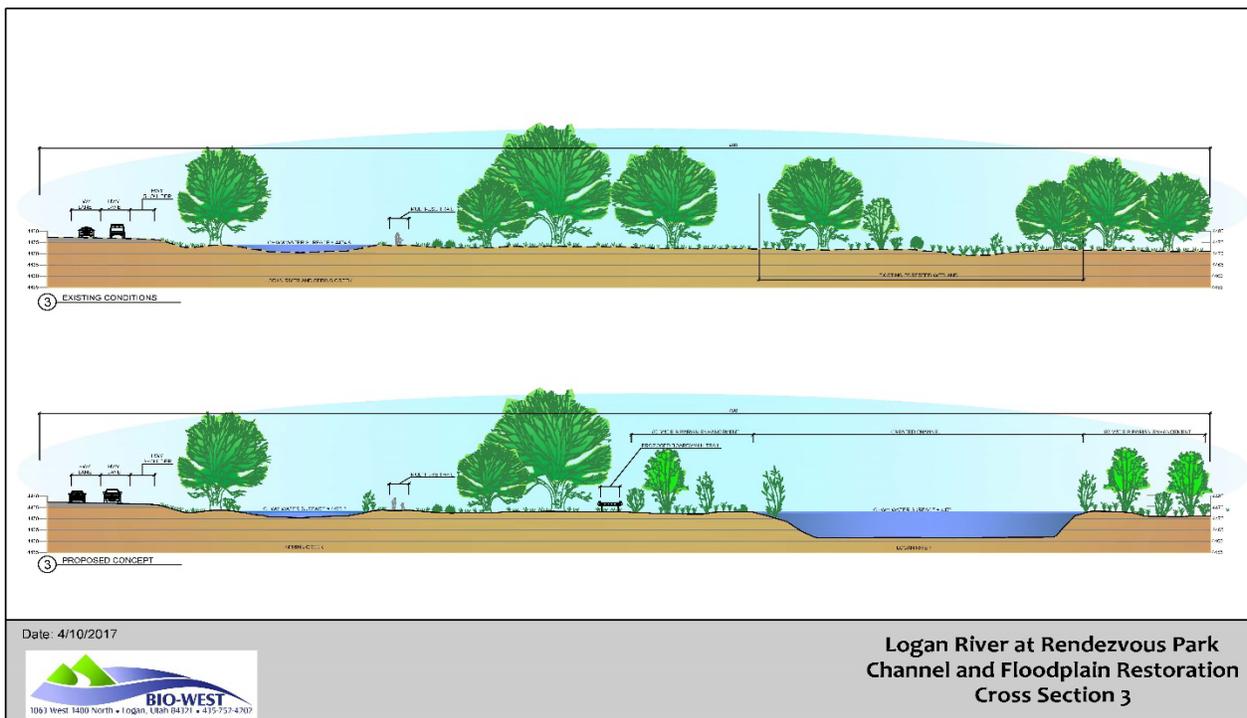
To implement the restoration project, all existing standing and downed crack willow trees will be removed within the new channel alignment and within a 50-foot buffer adjacent to the streambanks as shown on the proposed concept map and cross section. This is necessary to re-establish native shrubs along the restored stream channel.

The Logan River Restoration at Rendezvous Park project consists of the following construction activities:

- Excavating a new meander cut-off channel between the golf cart bridge and the railroad bridge that provides instream pool and riffle habitat, hydrologic connection to the floodplain (cut-off channel restoration area), and an accessible location to remove sediment accumulations
