JOINT PERMIT APPLICATION FORM
U.S ARMY CORPS OF ENGINEERS – FOR SECTIONS 404 AND 10
UTAH STATE ENGINEER’S OFFICE – FOR NATURAL STREAM CHANNELS

Project location or address:
Center Street Bridge Crossing Logan River

TECHNICAL REPORT

CENTER STREET BRIDGE FOUNDATION STABILIZATION

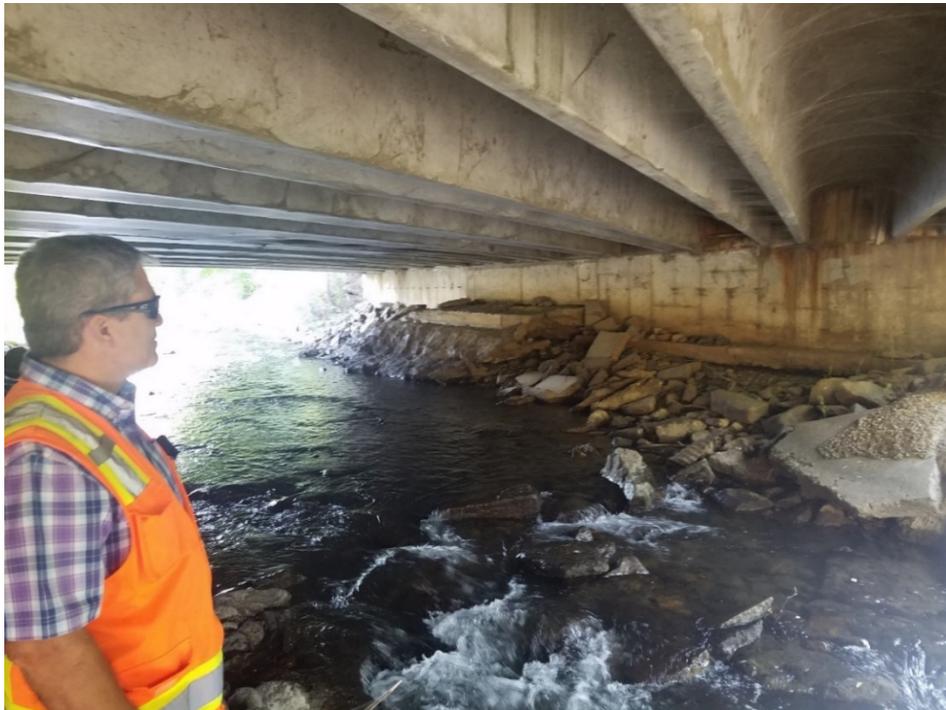
Figure 1.1 Picture of Footings on Bank Left

Figures 1.1 and 1.2 illustrate the problems that exist around the footings and foundations, including the scour beneath the footings, the rubble piles that have accumulated, and the further scour that has taken place. The figures also show the concrete rubble in the channel itself.

- Both foundations for the bridge consist of spread footings that were built at different times. The footings on both sides of the bridge have been scoured and eroded. When a tape measure was pushed up beneath them, the tape went in approximately 36 inches. Approximately ½ of the footing that is not supporting the structure.

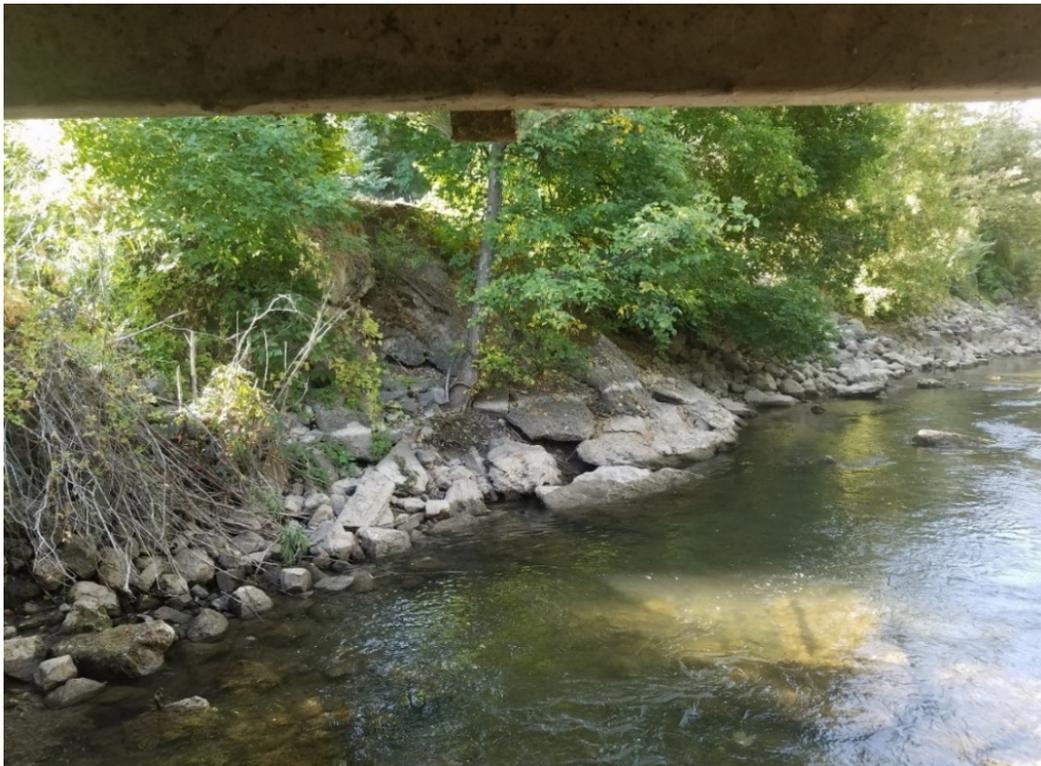
Figure 1.3 Downstream Face on Bank Left

Figures 1.3 and 1.4 show the dumping and concrete debris that has taken place, either to help stabilize the footings or simply as a disposal method. This has in turn choked the outlet of the bridge, causing localized higher velocities. An additional problem has been caused by a Siberian elm on the downstream right side bank, an invasive species of tree that has started growing in the cracks of the concrete, further complicating issues.

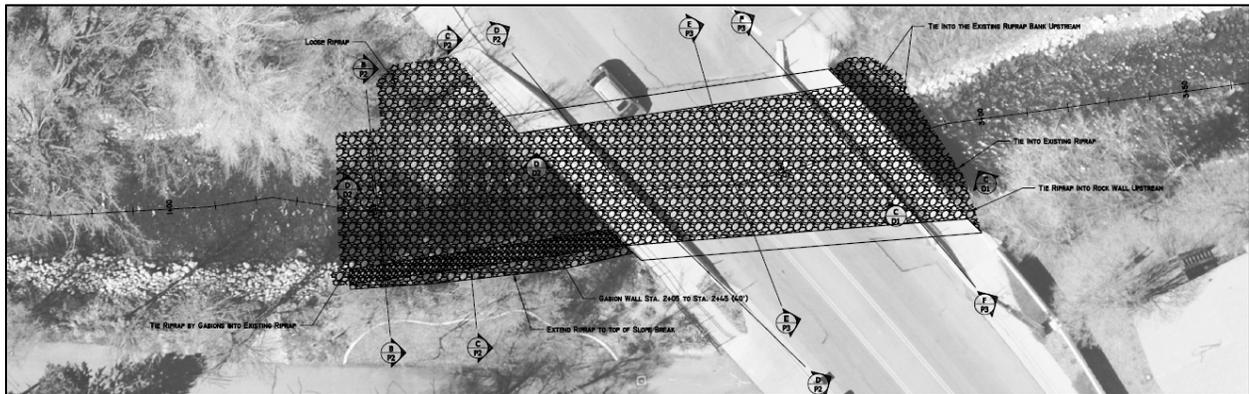
Figure 4.1 Armoring of Toes of Bridge and Abutments

Figure 4.1 shows the general plan approach from the design drawings. The design incorporates the use of engineered rip rap (based on the USACE EM-1110 references) to armor beneath the bridge and to reinforce the banks. A gabion wall is used on the south bank where the existing slopes are extremely steep.

Based on site visits and preliminary evaluations, FCE has evaluated the following configuration including armoring the toes of the bridge on bank right, the north side of the bridge. The work under the bridge will tie into the upstream rock wall on bank left, the south side of the bridge. However, the left bank downstream of the bridge will need either a rock wall or a gabion wall due to the steeper slope which currently approaches 45 degrees.

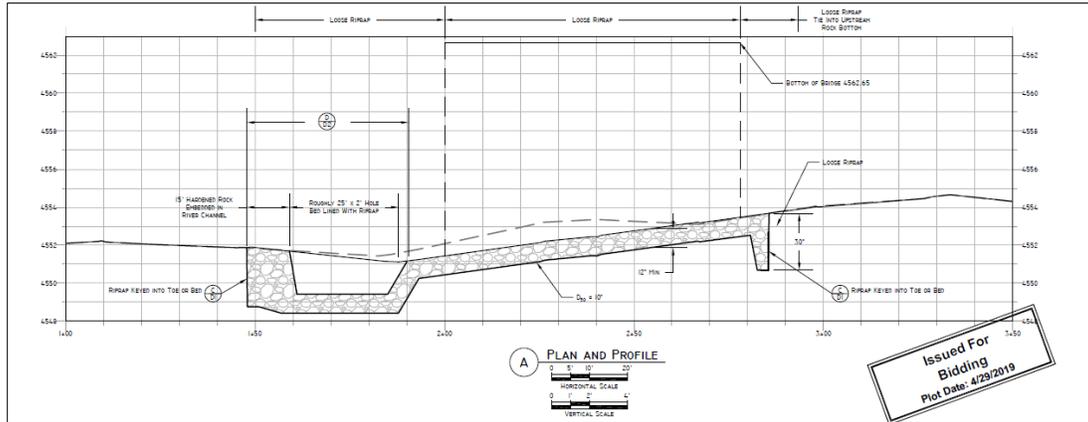
Figure 4.2 Centerline Through Bridge Showing a Stilling Basin and Armored Crest

Figure 4.2 illustrates the centerline section running through the bridge and the mitigation area. To mitigate velocities through the bridge a “stilling basin”, for lack of a better term, was designed to calm the flows somewhat and disperse the flows throughout the channel. During low flows, when oxygen levels can be a concern, this will create a habitat pool for fish and aquatic life. During high flows, it breaks energy and prevents the concentrated bridge velocities from scouring the channel downstream. The “stilling basin” is only about 30 inches deep and is located in the area where the existing flows were trying to cut through the accumulated concrete rubble.

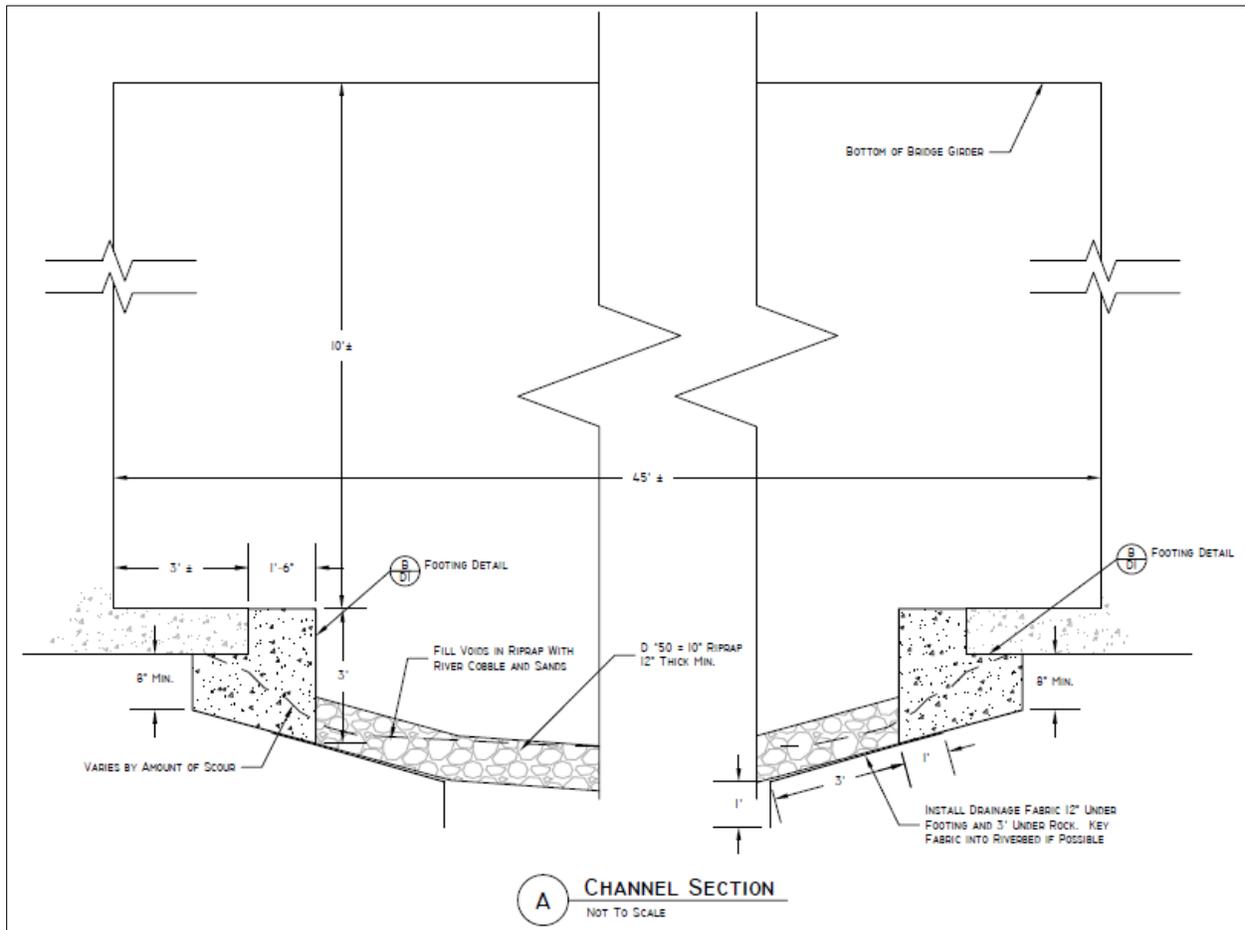
Figure 4.3 Cross Section Through Bridge Showing the Armored and Stabilized Footings

Figure 4.3 is a cross section showing the work that will be done beneath the existing bridge. The concrete rubble and debris will be removed, the footings reinforced, and the channel shaped to coincide with the upstream and downstream energy lines and flow patterns. The channel is armored with engineered rip rap.

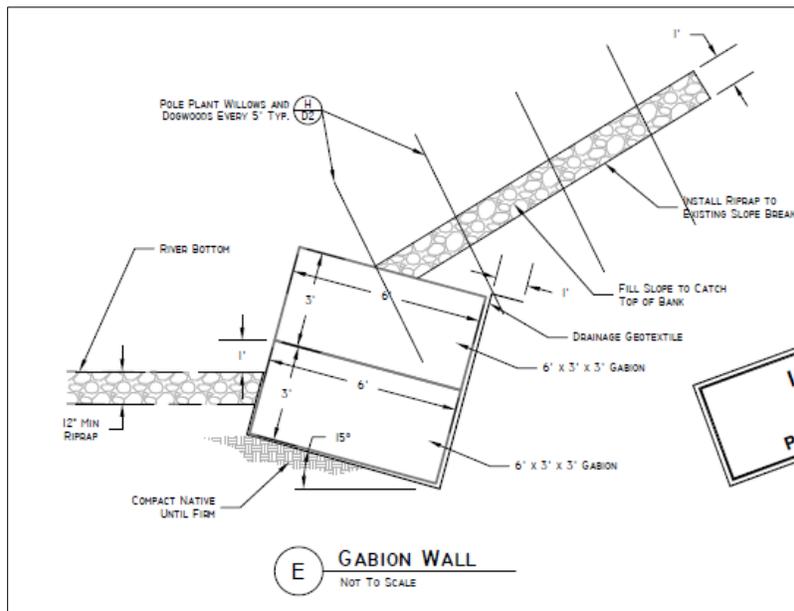
Figure 4.4 Gabion Wall Protection and Rip Rap Armoring

Figure 4.4 shows the use of the gabion wall. It is only two gabions high and is designed to catch the slope above, which will be graded to a 2h:1v slope. This slope will be armored with engineered rip rap to protect the bank during flood events. The rip rap and gabions will have pole plantings of coyote willow and Redozier dogwood to help revegetate the area. They will be placed on a five foot spacing in the rocks. Where possible, they will be planted at the same time the rock is being placed during the summer (least effective timing) to try and jump-start some of the growth with additional late fall dormant plantings (most effective) to further increase the density of the plantings.

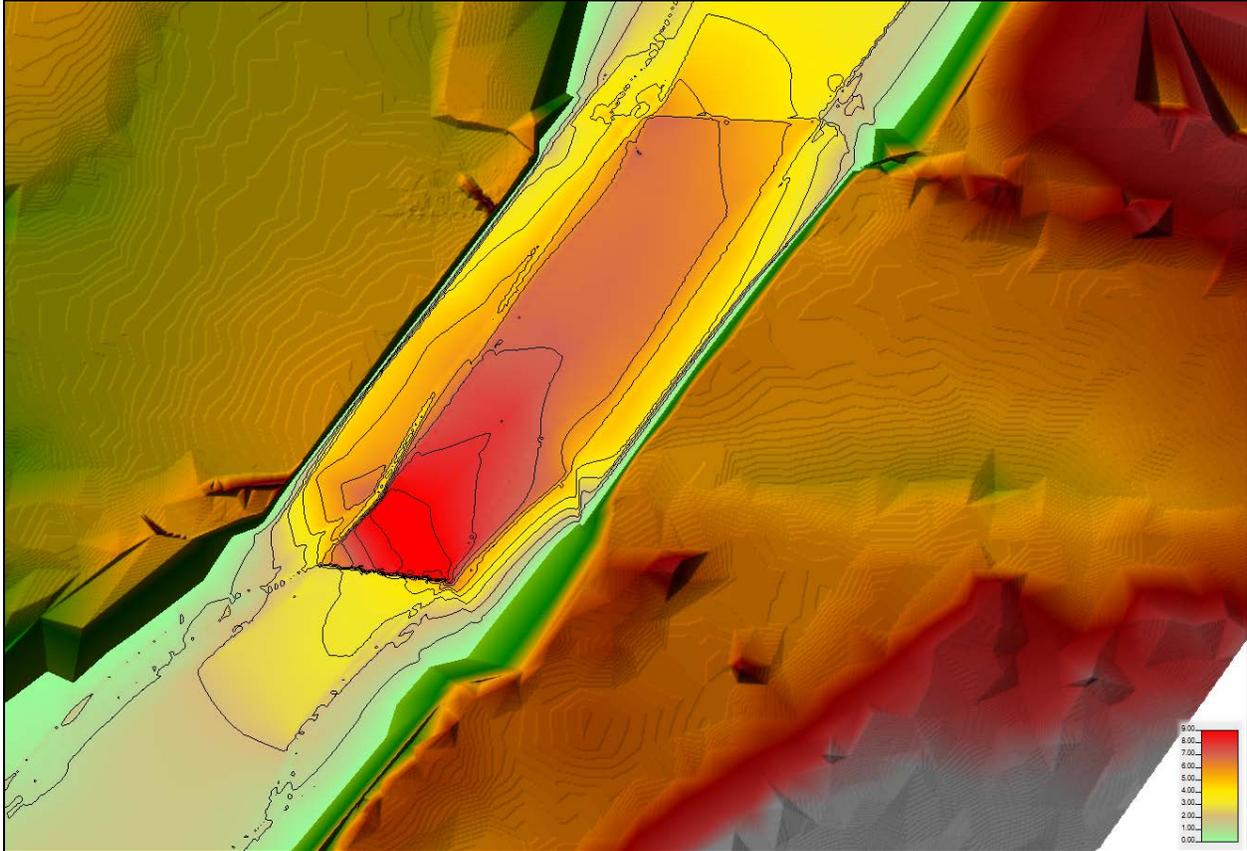
Figure 4.5 Existing Shear Stress at 2% Chance Flows Downward

These results are shown in the side by side comparison of shear stresses throughout the section. The shear units in HEC-RAS are in lbs per square foot. Figure 4.5 shows the shear stress through the bridge under the existing conditions in the two-percent chance event (50-year). This is a consequence of the concrete and rocks being dumped in order to try and protect the footings. However, as the model shows, the shear stresses created ranges from 6 to 10 lbs per square foot consistently, which tends to move the sediments and rock quite easily. However, Figure 4.6 shows that with the section being cleaned up, proper armor being installed, and the footing erosion being mitigated, the shear stresses are decreased to a range of 2.5 to 3.5 lbs per square foot. This significant reduction in shear stresses combined with improved armoring placement and construction will improve the flow through the bridge and help mitigate the bridge foundation scour.
